PRACTICAL DESIGN GUIDELINES FOR REPLACEMENT OF DEFICIENT BRIDGES
WITH LOW-WATER STREAM CROSSINGS IN THE RURAL MIDWEST

Submitted to the graduate degree program in Civil, Environmental and Architectural Engineering
and the Graduate Faculty of the University of Kansas in partial fulfillment of the requirements
for the degree of Master of Science.

Date Defended: July 28th, 2016

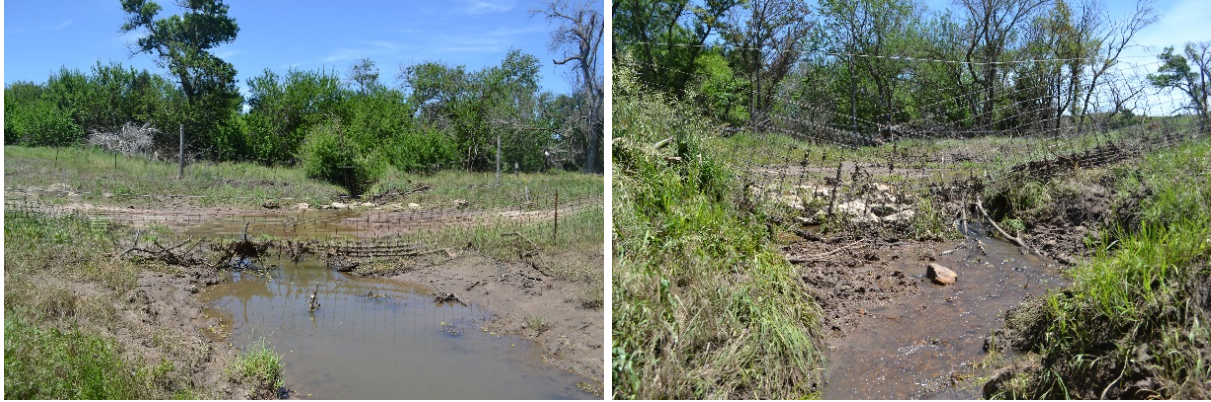
Figure 5-2: View of structure from upstream (left)

Figure 5-3: View of structure from downstream (right)

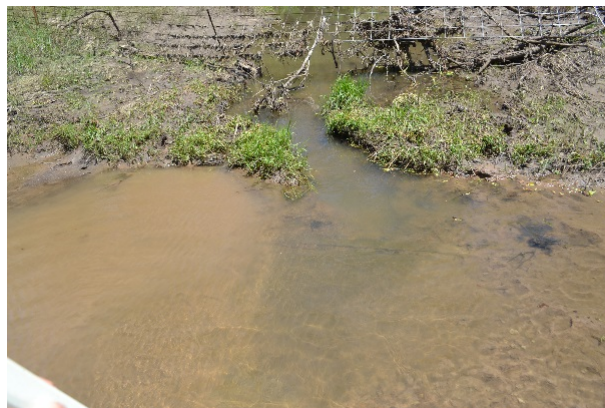
Figure 5-5: Low-flow channel on the upstream side of the ford

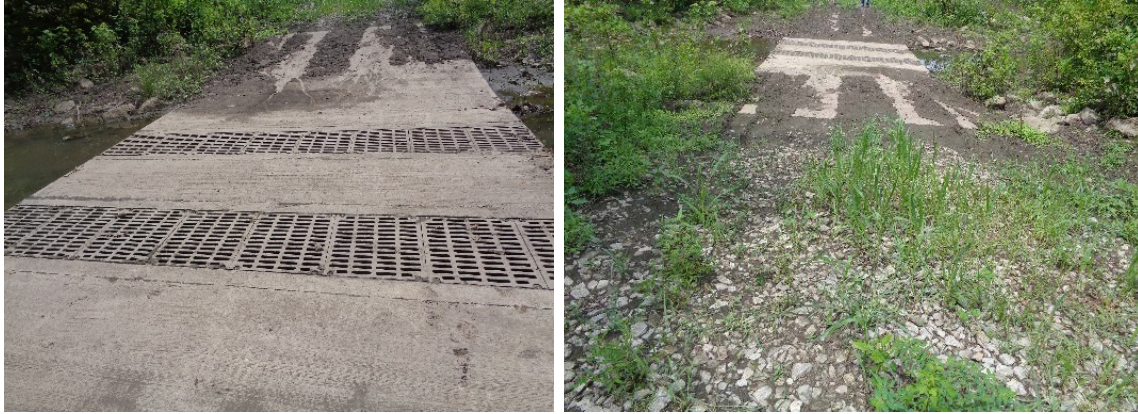
Figure 5-15: Close-up view of the grated troughs (left)

Figure 5-16: Rock surface material on south approach (right)

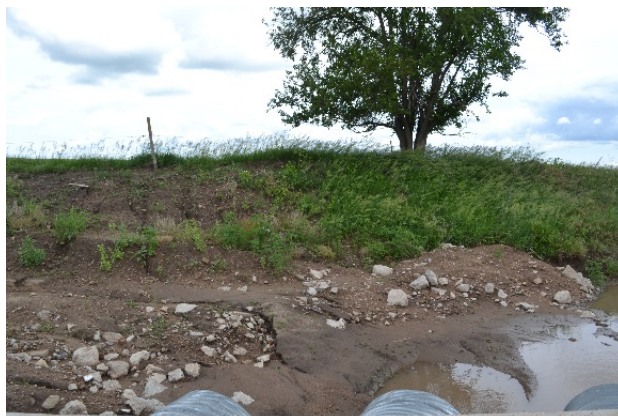
Figure 5-24: Washed-away aggregate stabilization on downstream left bank

This vented ford has performed very well in its first year of operation. No debris removal or roadway resurfacing has been required. However, some riprap on the downstream side left bank has washed away and will need to be replaced with larger rock at some point.

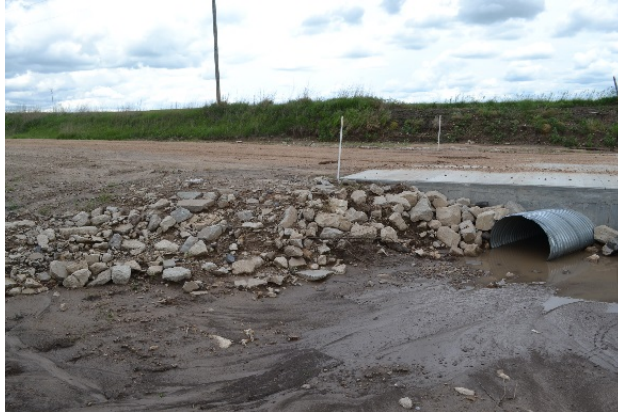
Figure 5-25: Bank stabilization and silt accumulation on downstream side of structure

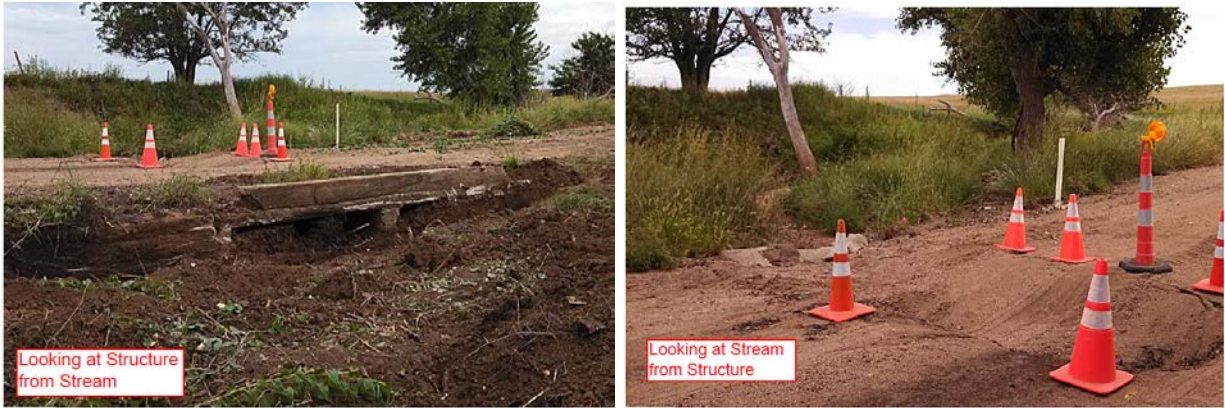
Figure 5-26: Old structure filled with sediment (left)

Figure 5-27: Partially collapsed culvert deck (right)

The previous structure was a two-cell 11-foot-wide by 8-foot-high reinforced concrete box culvert. As shown in Figures 5-26 and 5-27, the old culvert was almost completely silted in and its deck was collapsed.

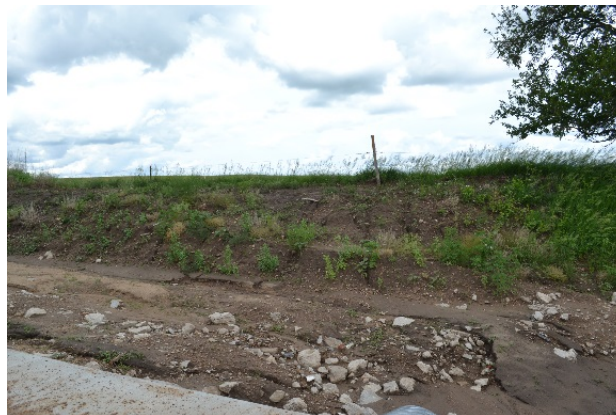
Figure 5-28: Sedimentation and roadway erosion on top of downstream bank stabilization, taken from deck of structure

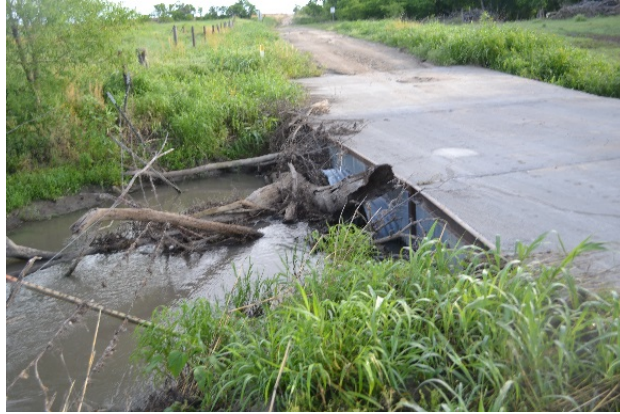
Figure 5-36: Timber buildup on the upstream face of structure

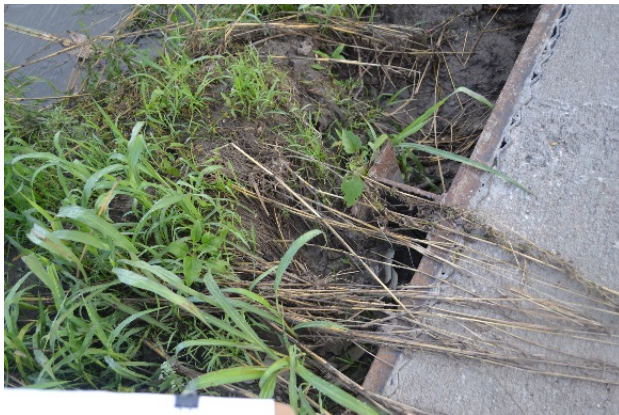
Figure 5-37: Buried steel H-pile on the upstream face of structure (left)

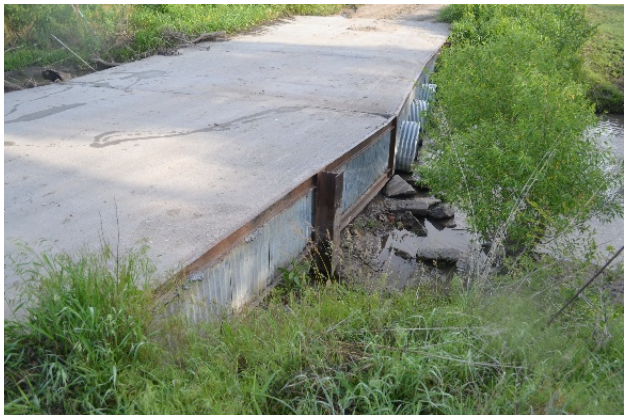
Figure 5-38: Exposed H-pile on downstream face of structure (right)

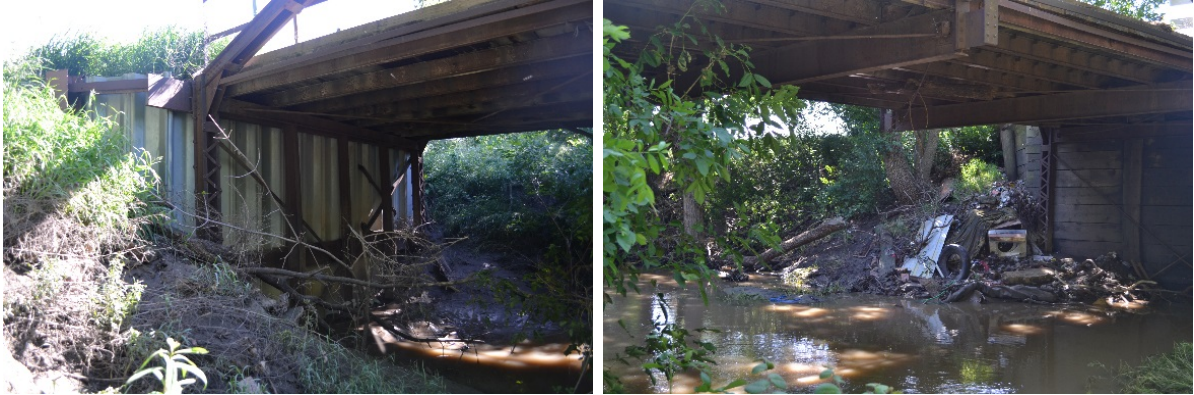
Figure 5-43: Right abutment retrofitted with steel sheet-pile (left)

Figure 5-44: Left abutment with original wood planks (right)

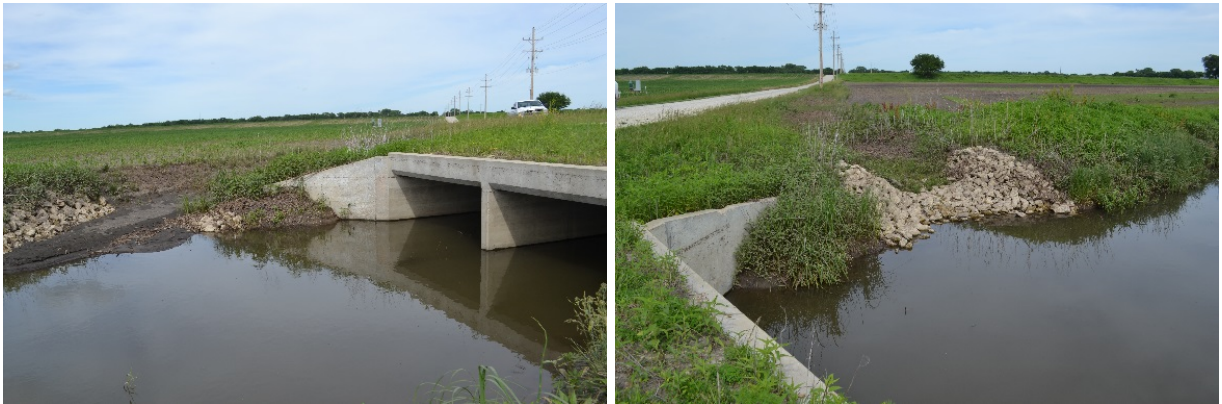
Figure 5-50: Upstream wingwall with riprap stabilization covered in silt (left)

Figure 5-51: Downstream wingwall with riprap stabilization (right)

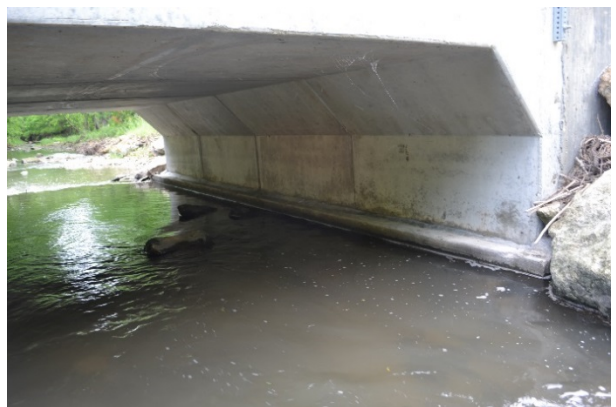
Figure 5-60: East abutment showing exposure of stem wall looking upstream (right)

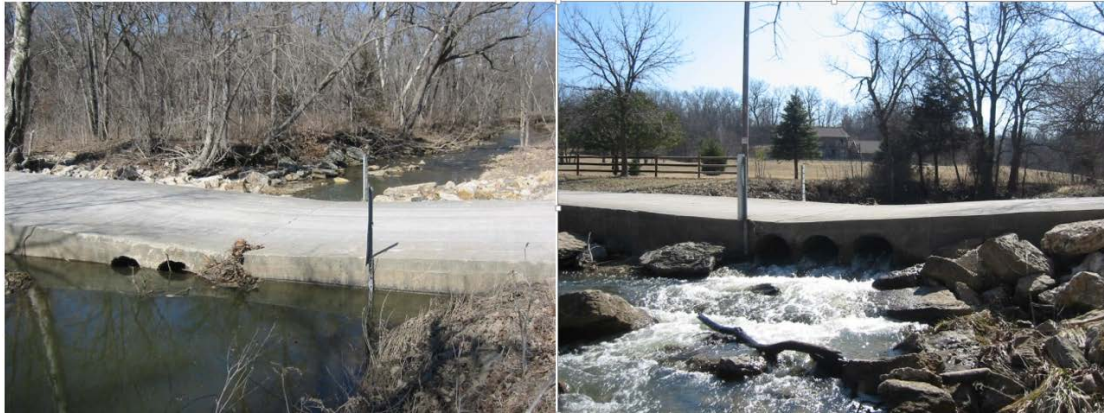
Figure 5-67: Upstream face of previous structure (left)

Figure 5-68: Downstream face of previous structure (right)

The previous structure was a vented ford with three 24-inch CMPs, as shown in Figures 5-67 and 5-68. The previous crossing on 175th Street over Camp Branch Creek was too often impassable due to overtopping and also impeded aquatic organism passage.

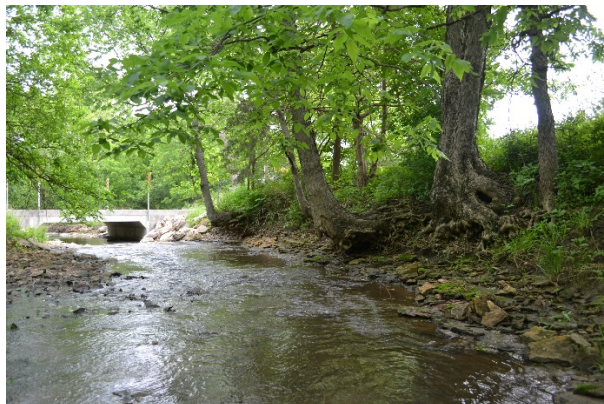
Figure 5-69: Minor lateral migration has occurred, threatening the stability of trees on the upstream east channel bank (left)

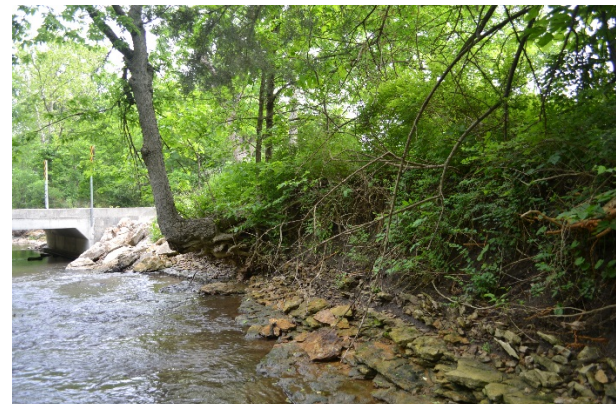
Figure 5-70: Bank scar on east upstream bank, which has rock outcroppings (right)

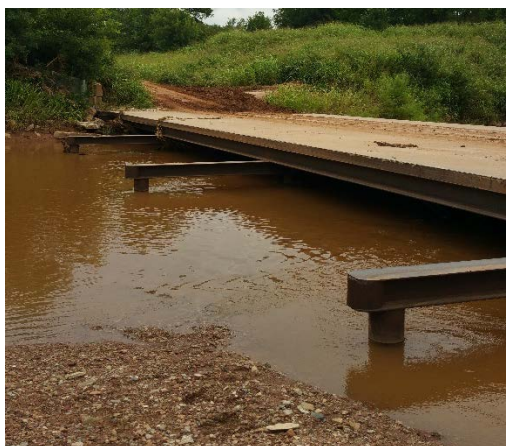
Figure 5-81: Debris-catching piers on the upstream side of bridge

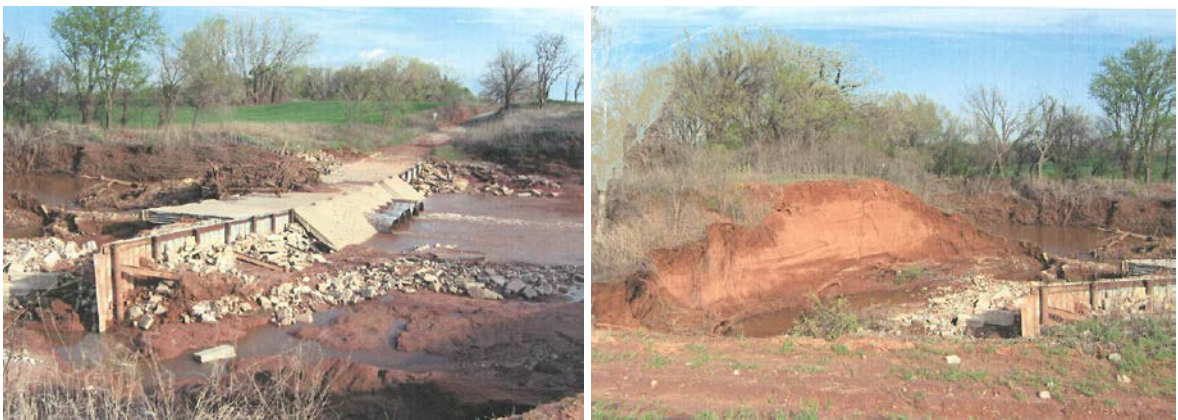
Figure 5-82: View of downstream side of old structure (left)

Figure 5-83: Washed-out south approach to old structure (right)

The previous structure was a vented ford with five 72-inch corrugated steel vent pipes. Reinforced concrete headwalls and wing walls protected the structure. The upstream and

downstream sides of the structure were sloped to help pass debris over the structure during high flows. On the upstream side the CMPs were mitered flush with the sloping headwall. On the downstream side the CMPs extended a few feet beyond the sloped edge of the structure. A large difference between the streambed elevation and the top of deck elevation and timber-laden flow were the main reasons the old structure had to be replaced. The roadway surface was approximately 10 feet higher than the streambed elevation. The old structure was replaced because its vents were often clogged with large woody debris, which caused frequent flooding of the roadway and on one occasion caused the south approach to wash out.

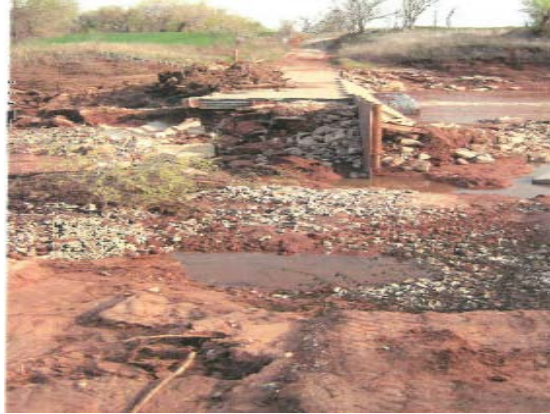
Figure 5-84: Looking north on S. Chicaskia Road at washed-away approach

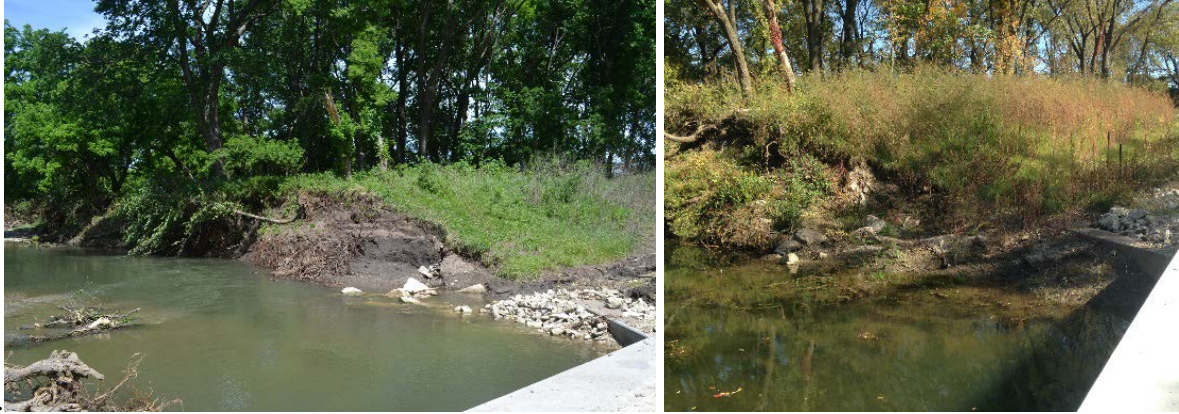
Figure 5-91: Downstream right bank erosion from flood waters (left)

Figure 5-92: Comparison photo of the same bank taken eight months earlier (right)

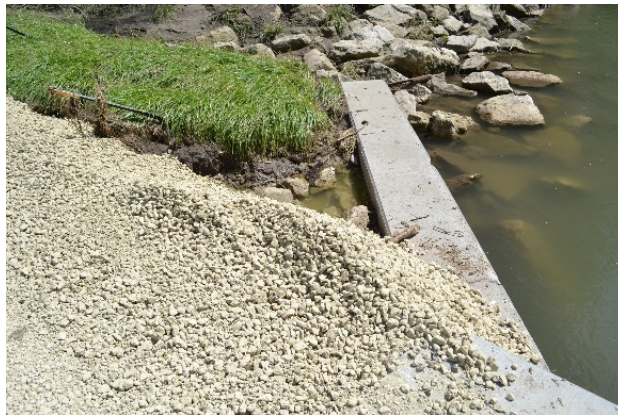
Figure 5-97: Scouring on the upstream right-bank wing wall with newly applied aggregate on the approach and edge of the bridge deck to combat erosion
